Table 1: Images taken using a digital camera to show the wear scars on the PEEK plates after 1MC wear simulation. Due to the difficulty in photographing the scratches on the plates, the wear scar has been marked in blue to highlight the scratches. The photographs are representative of the plates tested.

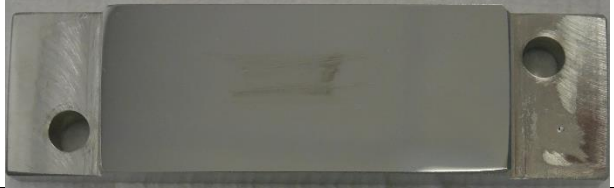
0% Elevated temperature

Table 3: Images taken using a digital camera to showing cobalt chrome plates. When water or low concentrations of protein were used in the lubricant, polymer transfer was visible on the plates. In high protein concentration lubricant (90%), at room temperature, there was a deposit thought to be protein inside the wear area; at elevated temperature, there was evidence of protein precipitation on the plate outside of the wear scar.
